Bay Bridge Update to CTC – August 6, 2013

On July 8, 2013, TBPOC issued investigative report on A354 Grade BD High-Strength Steel Rods with findings and provisional resolution on SAS high-strength bolts

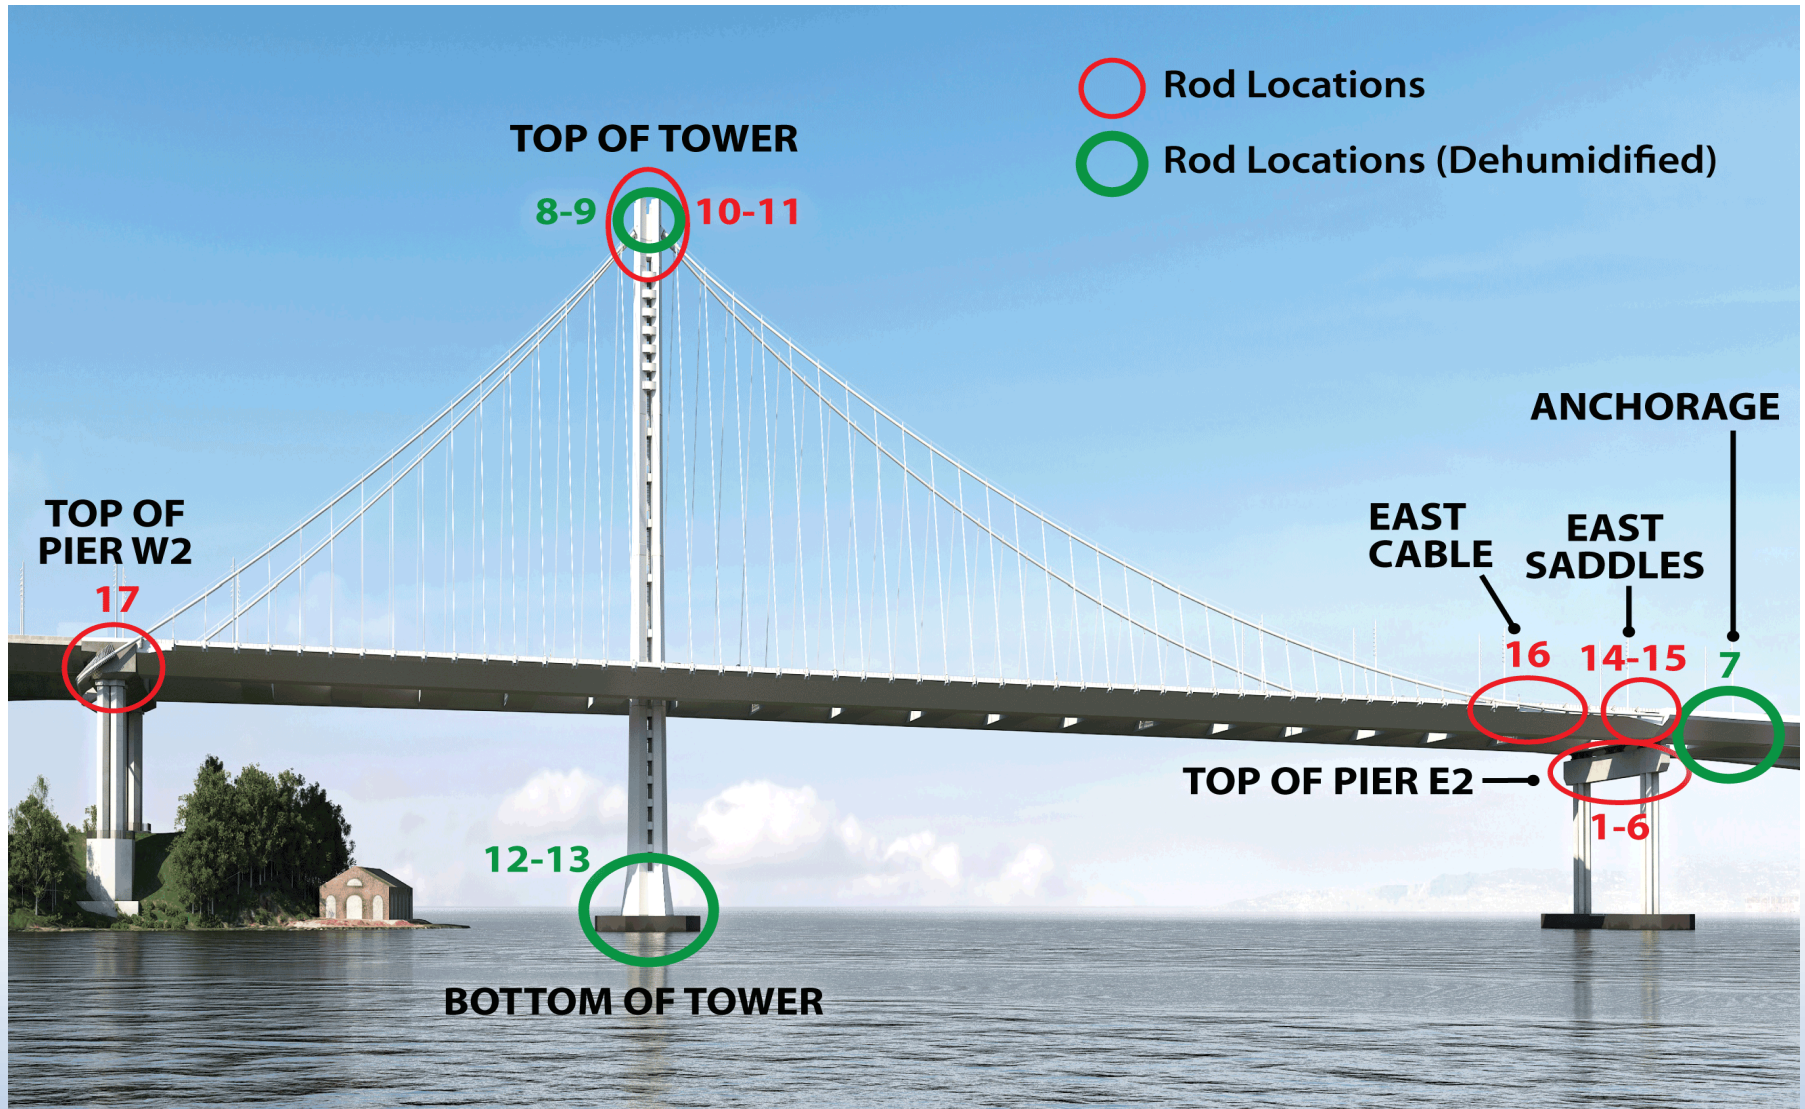
A354 Grade BD Rod Locations on the SAS Bridge

Item No.	Location	Component	Quantity Installed	Diameter (in)	Length (ft)	Tension (fraction of Fu*)
1	Top of Pier E2	Failed Shear Key Anchor Rods (2008)	96	3	10-17	0.7
2		Bearing & Shear Key Anchor Rods	192	3	22-23	0.7
3		Shear Key Rods (top)	320	3	2-4.5	0.7
4		Bearing Rods (top)	224	2	4	0.7
5		Bearing Assembly	96	1	2.5	0.6
6		Bearing Retainer Ring Plate Assembly	336	1	0.2	0.4
7	Anchorage	Parallel Wire Strands (PWS) Anchor Rods	274	3.5	28-32	0.3
8	Top of Tower	Saddle Tie Rods	25	4	6-18	0.7
9		Saddle Turned Rods	108	3	1.5-2	0.5
10		Saddle Grillage	90	3	1	0.1
11		Outrigger Boom	4	3	2	0.1
12	Bottom of Tower	Tower Anchor Rods (Type 1)	388	3	26	0.5
13		Tower Anchor Rods (Type 2)	36	4	26	0.4
14	East Saddles	East Saddle Anchor Rods	32	2	3	0.1
15		East Saddle Tie Rods	18	3	5	0.1
16	East Cable	Cable Band Anchor Rod	24	3	10-11	0.2
17	Top of Pier W2	Bikepath Anchor Rods	43	1.2	1.5	TBD
		TOTAL QUANTITY	2,306
